Körnungslinie

Bearb. - Nr.: 3079  
Anlage - Nr.: 1/3.1

Bearb. - Nr.: 3079  
Anlage - Nr.: 1/3.2

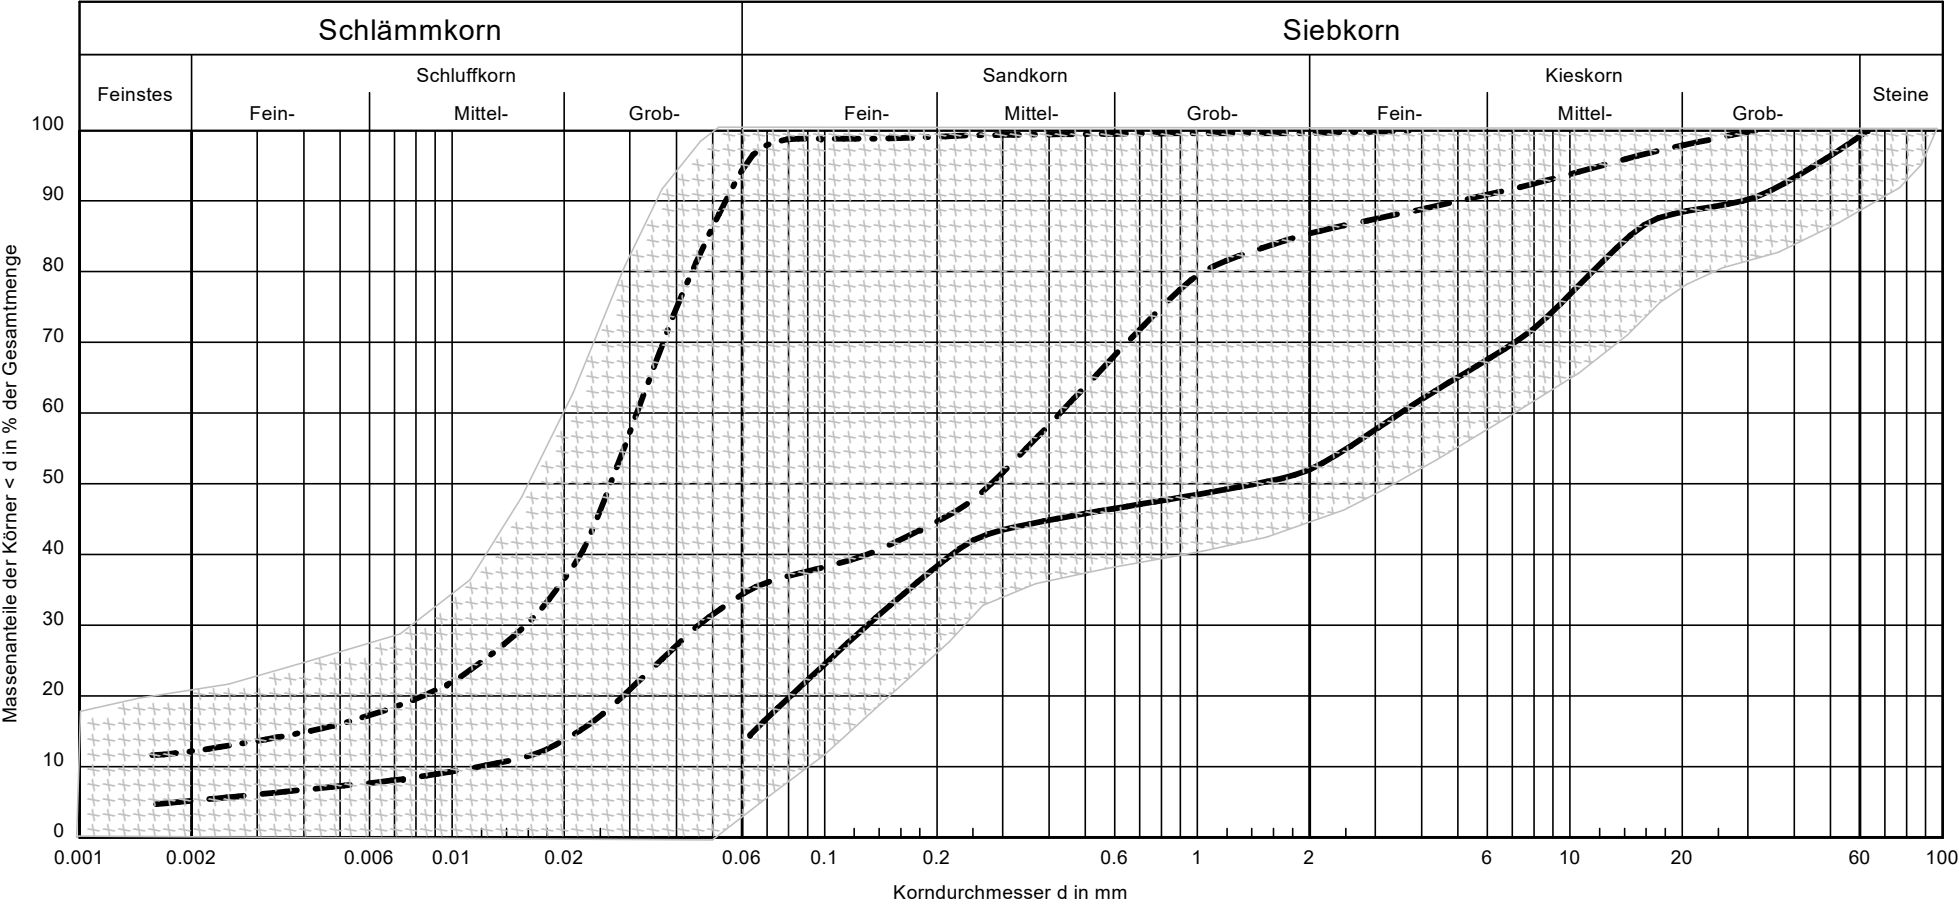
| Labor-Nr. | 7288 | 7289 | 7290 |
| Entnahmestelle | RKS 4 | RKS 2 | RKS 4 |
| Entnahmetiefe ( m ) | 1,7 - 2,8 | 0,2 - 1,0 | 0,0 - 0,7 |
| Bodenart | A (G, u', s̄), k | A (S, ū, g', h) | A (U, t') |
| Wassergehalt ( % ) | 6,0 | 12,2 | 14,9 |
| Signatur | ———— | --- | - . - . - |

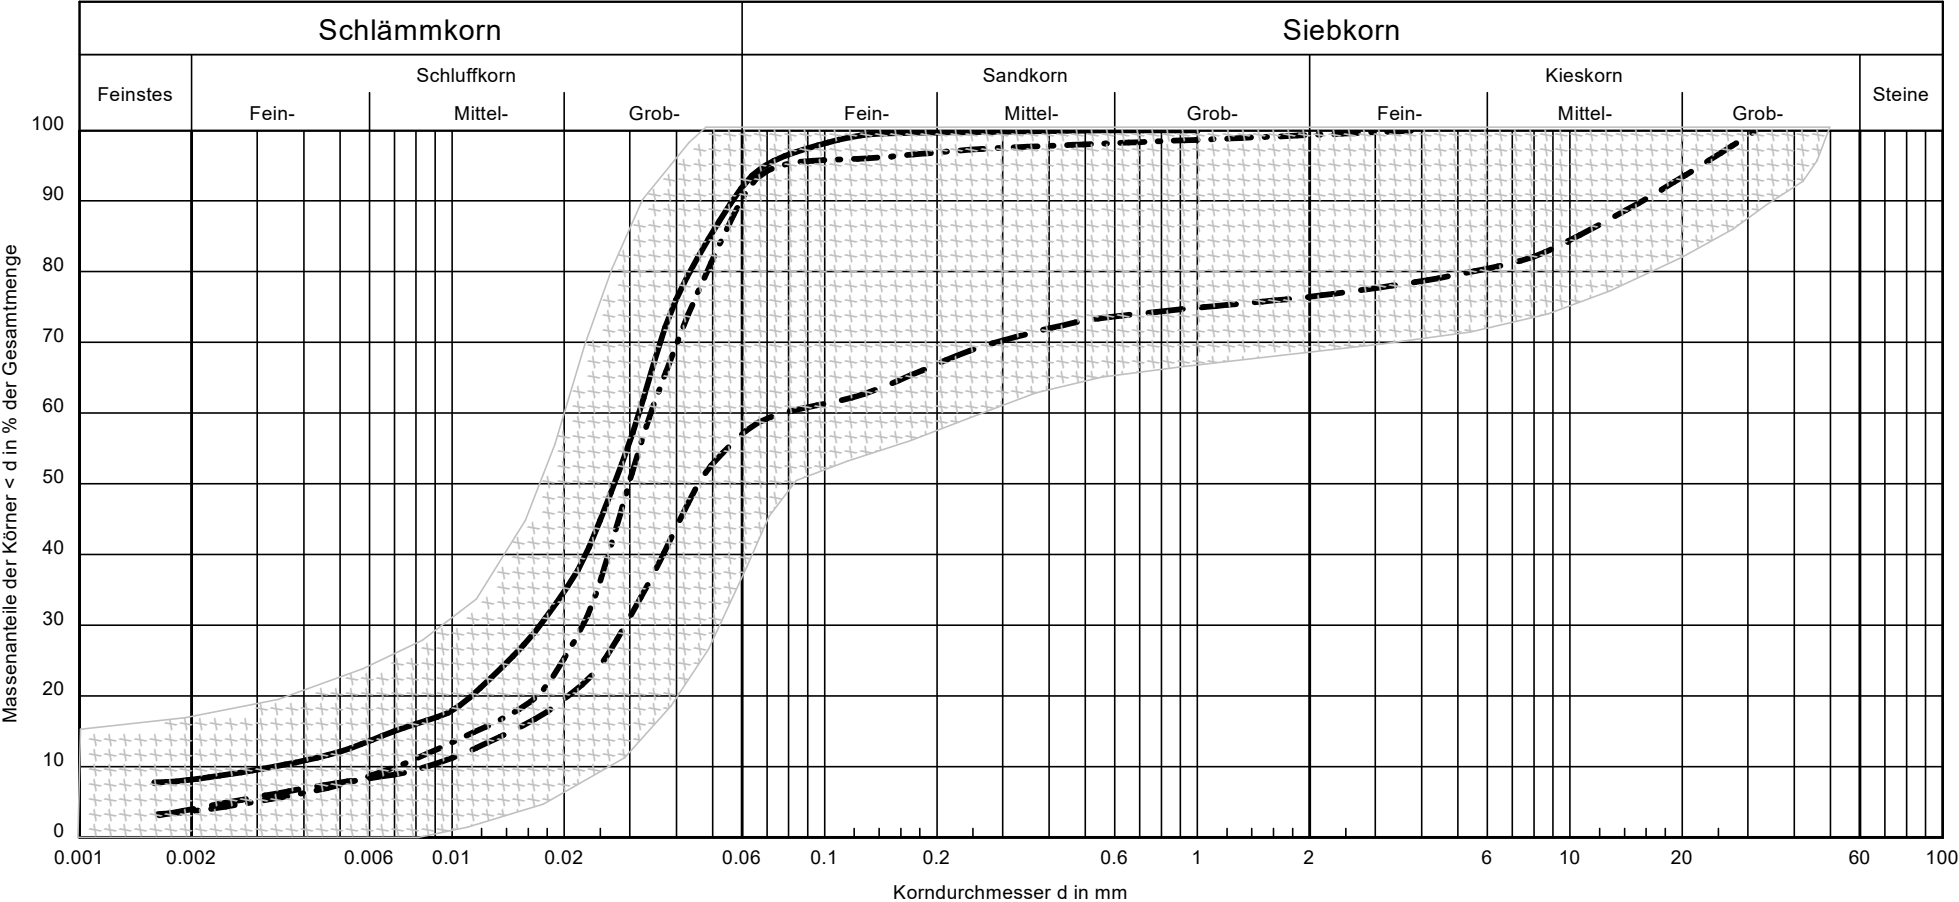
Körnungslinie

| Labor-Nr. | 7291 | 7292 | 7293 |
| Entnahmestelle | RKS 5 | RKS 1 | RKS 3 |
| Entnahmetiefe ( m ) | 1,3 - 2,2 | 4,0 - 4,8 | 4,6 - 5,6 |
| Bodenart | gU, t', s' | U, s, g, k | gU, s' |
| Wassergehalt ( % ) | 14,8 | 16,4 | 21,0 |
| Signatur | — — — — | - - - - | - . - . |
