# Zustandsgrenzen nach DIN 18 122

Klinikstraße, Bochum

Probenbezeichnung : KRB 14/5

Probenbezeichnung : KRB 15/3

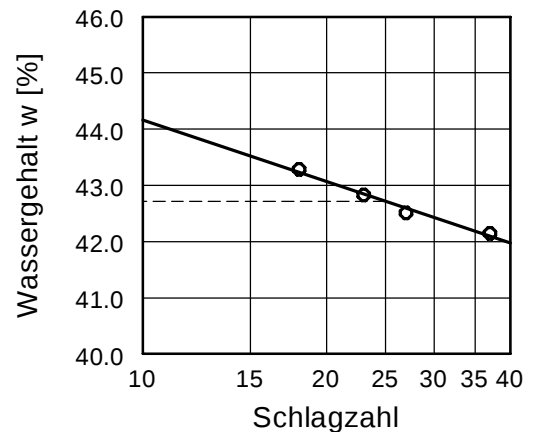
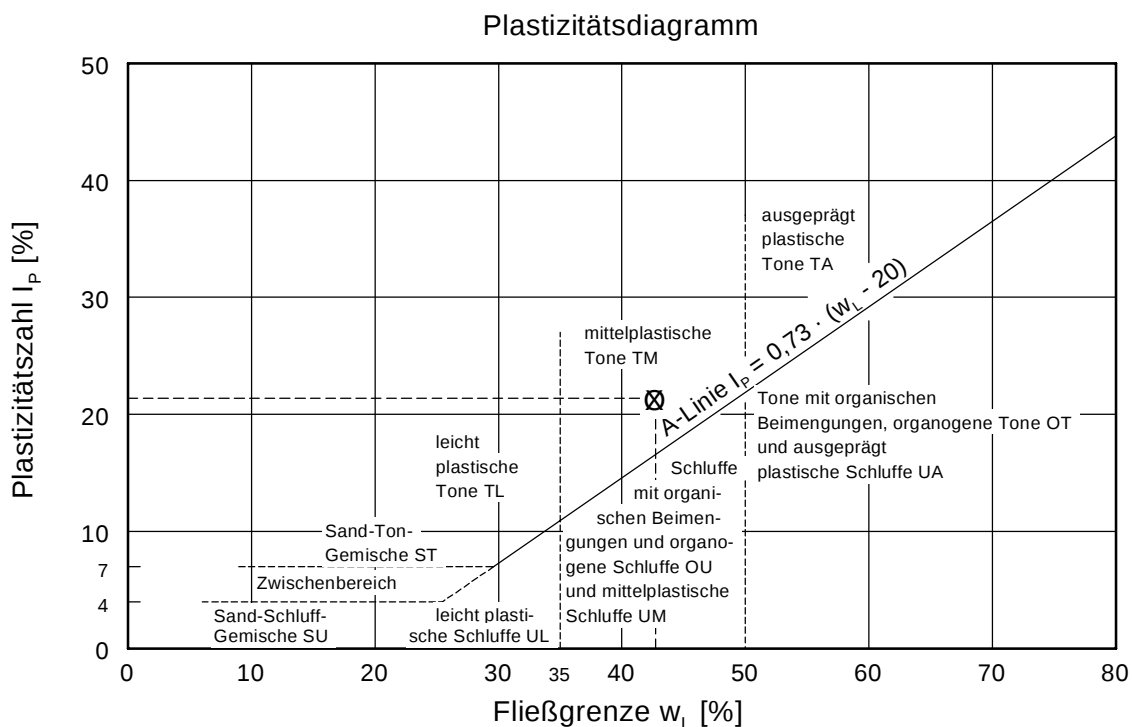
Wassergehalt  $w =$  21.6 %  
 Fließgrenze  $w_L =$  42.7 %  
 Ausrollgrenze  $w_P =$  21.3 %  
 Plastizitätszahl  $I_p =$  21.4 %  
 Konsistenzzahl  $I_c =$  0.99

| Nr. | 1 | 2 | 3 | 4 | 5 | 6 | 7 |
|---|---|---|---|---|---|---|---|
| w [%] | 43.28 | 42.83 | 42.51 | 42.15 | 21.64 | 21.29 | 21.01 |
